An Investigation of the Therac-25 Accidents

Nancy G. Leveson, University of Washington

Clark S. Turner, University of California, Irvine

A thorough account of the Therac-25 medical electron accelerator accidents reveals previously unknown details and suggests ways to reduce risk in the future.

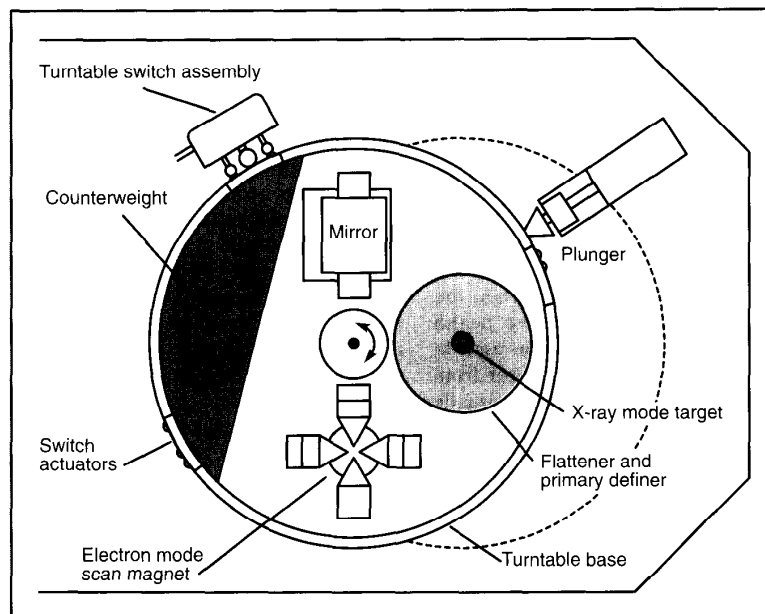
Figure B. Upper turntable assembly.

crosswitch codes (which could be caused by a single open-circuit fault on the switch lines) could produce an ambiguous position message for the computer.

hazard of dual-mode machines: If the turntable is in the wrong position, the beam flattener will not be in place.

No accelerator beam is expected in the field-light position. A stainless steel mirror is placed in the beam path and a light simulates the beam. This lets the operator see precisely where the beam will strike the patient and make necessary adjustments before treatment starts. There is no ion chamber in place at this turntable position, since no beam is expected.

cate turntable position that tolerated a 1-bit error: The code would still unambiguously reveal correct position with any one microswitch failure.

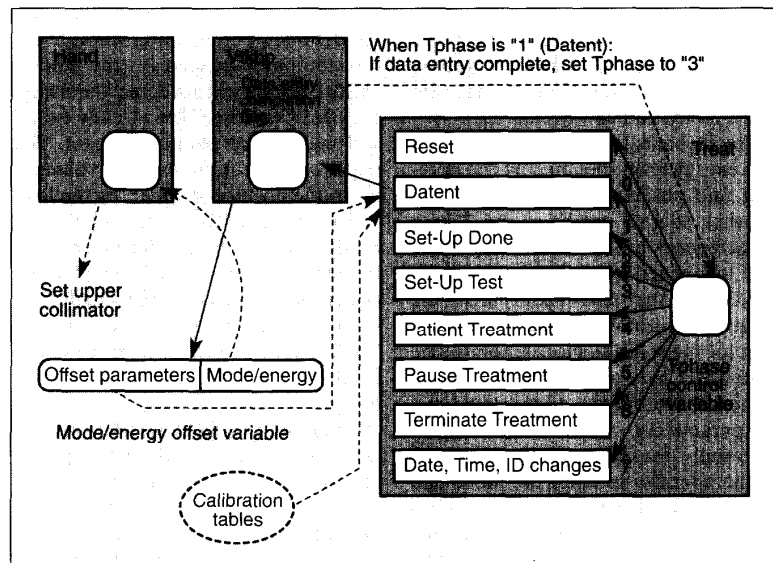
Figure 2. Tasks and subroutines in the code blamed for the Tyler accidents.

As described in the sidebar on Therac-25 software development and design, the treatment monitor task (Treat) controls the various phases of treatment by executing its eight subroutines (see Figure 2). The treatment phase indicator variable (Tphase) is used to determine which subroutine should be executed. Following the execution of a particular subroutine, Treat reschedules itself.

One of Treat's subroutines, called Datent (data entry), communicates with the keyboard handler task (a task that runs concurrently with Treat) via a

shared variable (Data-entry completion flag) to determine whether the prescription data has been entered. The keyboard handler recognizes the completion of data entry and changes the Data-entry completion variable to denote this. Once the Data-entry completion variable is set, the Datent subroutine detects the variable's change in status and changes the value of Tphase from 1 (Data Entry) to 3 (Set-Up Test). In this case, the Datent subroutine exits back to the Treat subroutine, which will reschedule itself and begin execution of the Set-Up Test subroutine. If the Data-entry completion variable has not been set, Datent leaves the value of Tphase unchanged and exits back to Treat's main line. Treat will then reschedule itself, essentially rescheduling the Datent subroutine.

Upon exit from the Magnet subroutine, the data-entry subroutine (Datent) checks the data-entry completion variable. If it indicates that data entry is complete, Datent sets Tphase to 3 and Datent is not entered again. If it is not set, Datent leaves Tphase unchanged, which means it will eventually be re-scheduled. But the data-entry completion variable only indicates that the cursor has been down to the command line, not that it is still there. A potential race condition is set up. To fix this, AECL introduced another shared variable controlled by the keyboard handler task that indicates the cursor is not positioned on the command line. If this variable is set, then prescription entry is still in progress and the value of Tphase is left unchanged.
